## *Glendale Center Retail Building: Vertical Drain Line Rehabilitation*

Location: Glendale, California

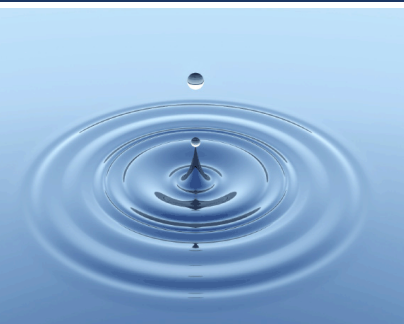
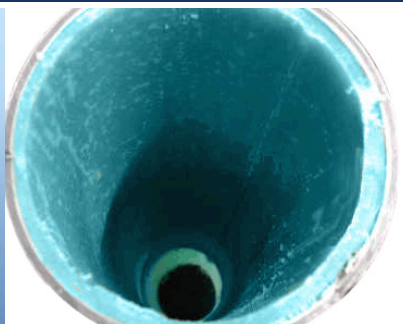
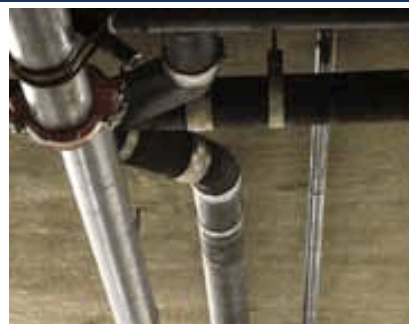
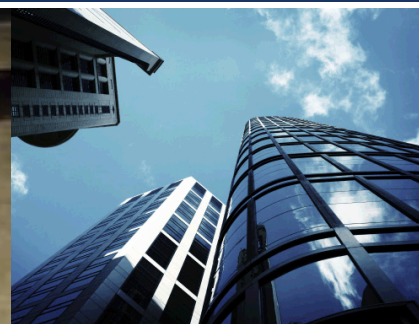
Branch pipe lines from the urinals were experiencing low flow because of buildup and corrosion. The cast iron system consists of 170 feet of pipes with a 4" diameter and 24 feet of 2" branch lines.

Nu Flow cleaned and rehabilitated all 14 floors of the vertical drain line with their structural liner. Thanks to Nu Flow's no-dig technology, work took one week with minimal disruption to tenants, compared to a three week destructive job for traditional repairs and re-piping.
