Brittany Park Retirement Community: Entire Potable Rehabilitation

Location: Seattle, Washington

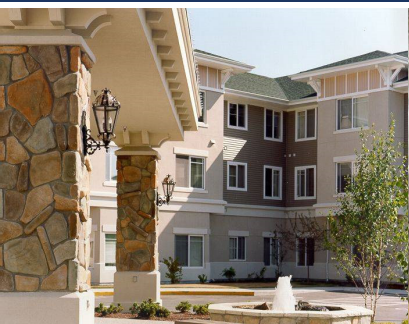
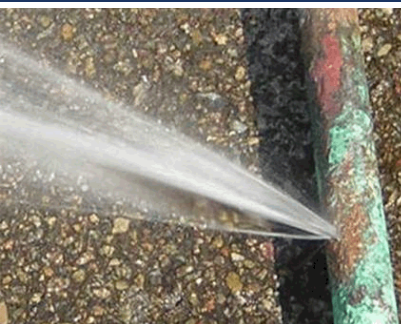
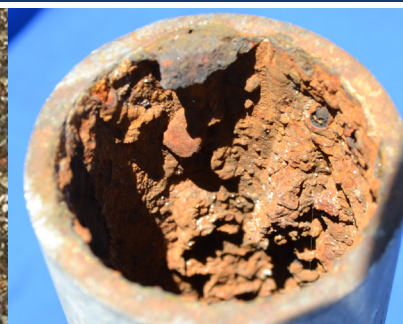
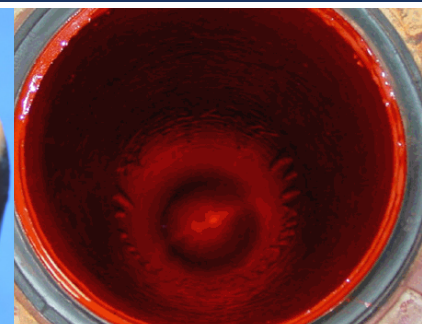
The aged galvanized hot and cold potable lines experienced pinhole leaks, rusty water and low flow. The leaks occurred in the seniors' apartments, under the slab. The customer sought a long-term solution that would be cost-effective and not inconvenience the residents.

American Pipe Lining, a Nu Flow company, provided the only feasible solution for the customer. A protective coat of epoxy was applied to all of the hot and cold water lines to prevent future problems. Our no-dig technology did not cause destruction and temporary water was given to residents to minimize disruption.
