Eastgate Square Mall: Roof Drain Rehabilitation

Location: Hamilton, Ontario, Canada

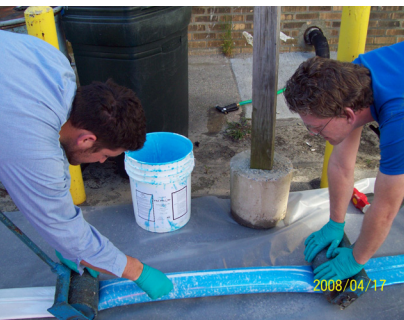
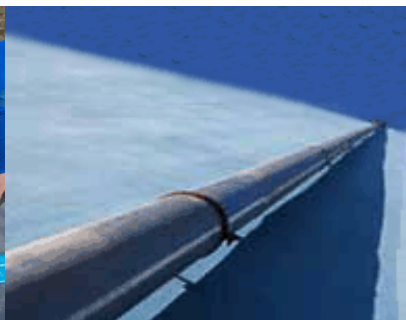
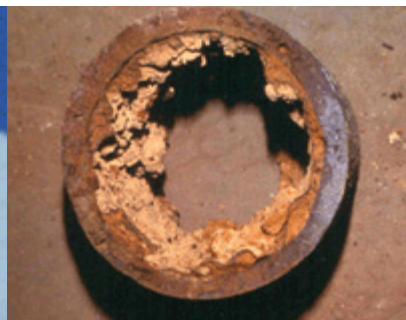
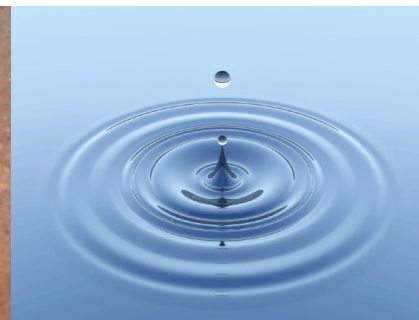
Cast iron roof drain system was installed in the 1970s and had aged, creating cracks and leaks. The system is 30 feet tall with a 4" diameter, and includes a "Y" connection and a 90-degree elbow.

Wiring and pipes blocked access to the drain system, so traditional pipe replacement was not an option. Structural liner was installed inside the existing pipe system, covering pinhole leaks and preventing future corrosion and cracks. Operations inside the mall continued as normal.
