## ***Elmendorf Air Force Base Hospital: Potable Rehabilitation***

**Location:** Anchorage, Alaska

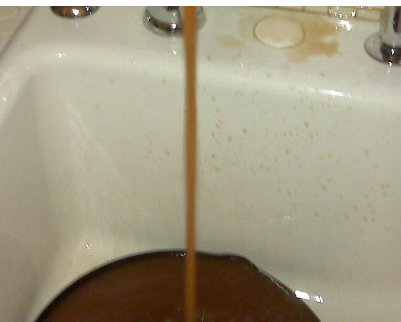
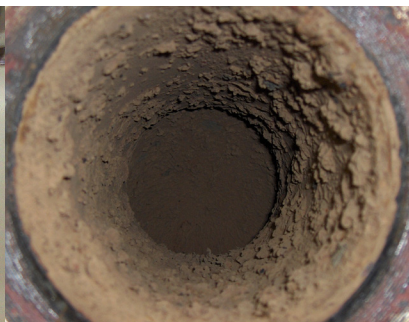
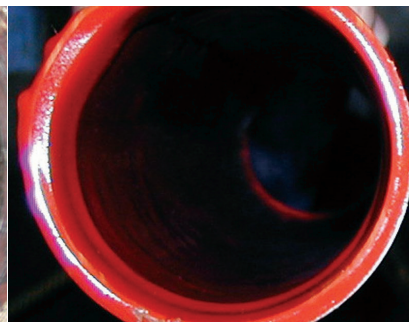
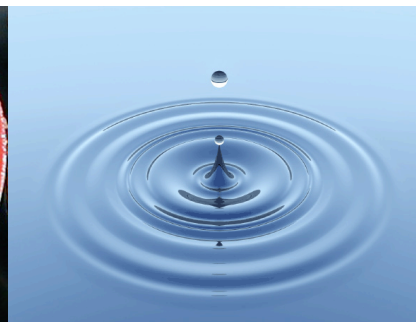
In 1999, the base's \$400 million hospital had just been built. Unfortunately, when soft water ran through the black iron potable lines, it pulled iron out from the pipes, which made the water red. The new hospital could not open until this problem was solved, so a repair was needed quickly.

American Pipe Lining, a Nu Flow company, had the perfect solution for the customer. Our blown-in epoxy coating was applied via existing access points to the pipes, so there was no demolition to the new building. Technicians coated about 2 miles of pipes, ranging from 3" to 8" in diameter.
