Liquefied Natural Gas Plant: Potable System Rehabilitation

Location: Baja California, Mexico

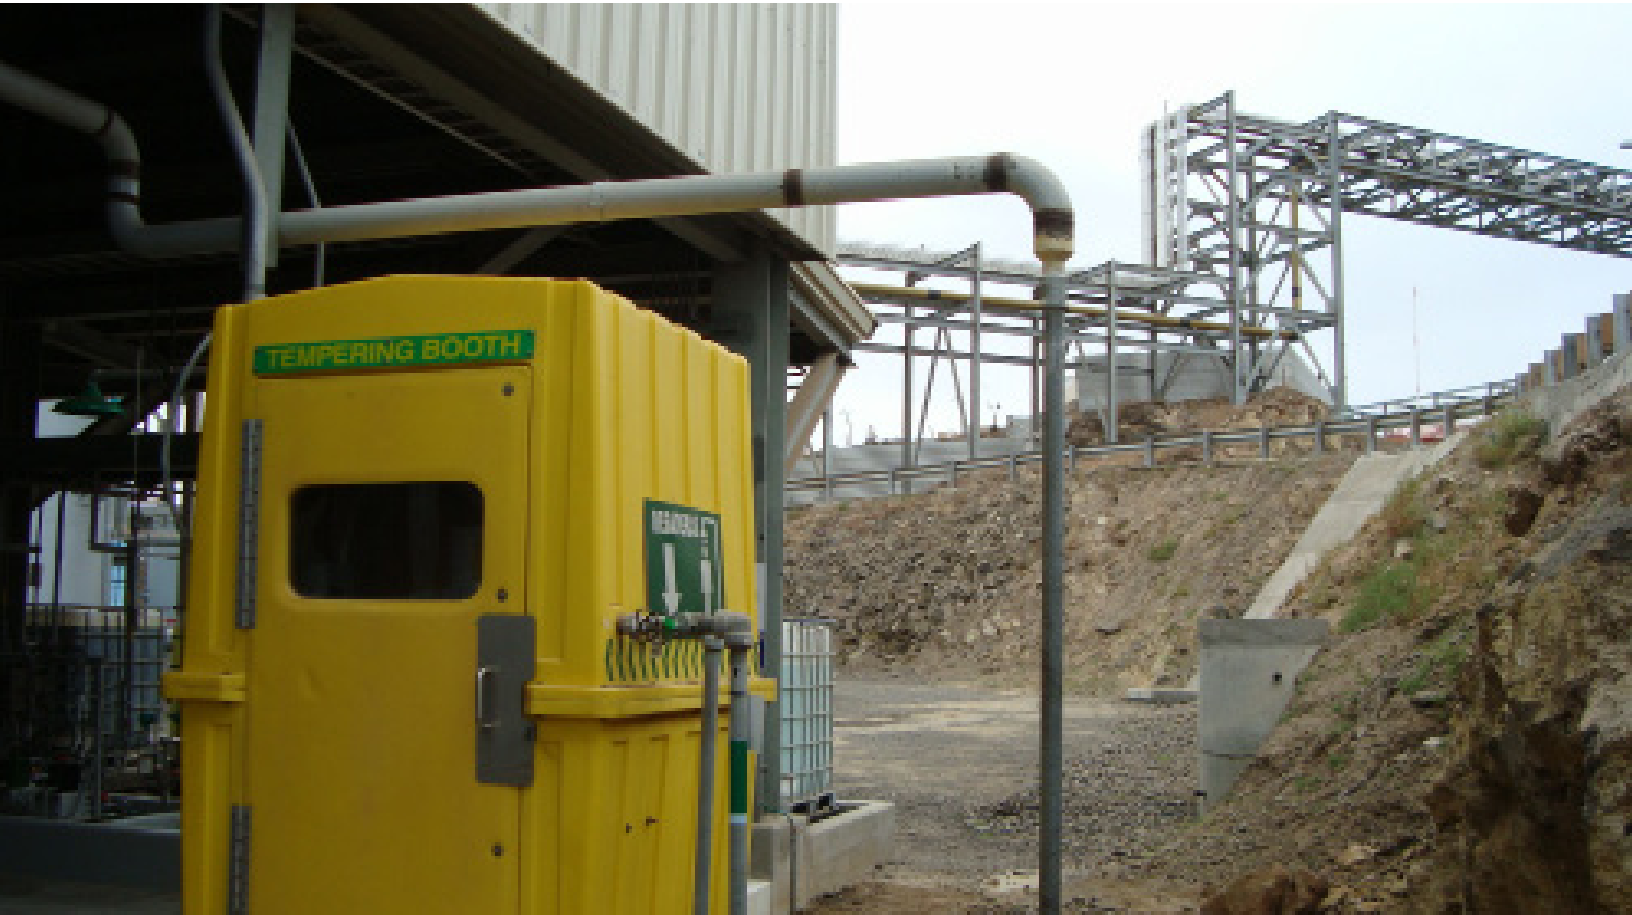
A potable filtration line at a liquefied natural gas plant experienced constant failure and leaks due to the effects of purified water corrosion. The carbon steel pipes are organized in a maze-like pattern across the ceiling, which made them challenging to access.

Nu Flow cleaned the potable system and then lined it using our patented blown-in epoxy coating, which created a thin, protective coating that will prevent future problems. This eco-friendly process means less mess, less hassle and less cost for the customer.
