## ***General Atomics: Sanitary Drain Line System Rehabilitation***

Location: San Diego, California

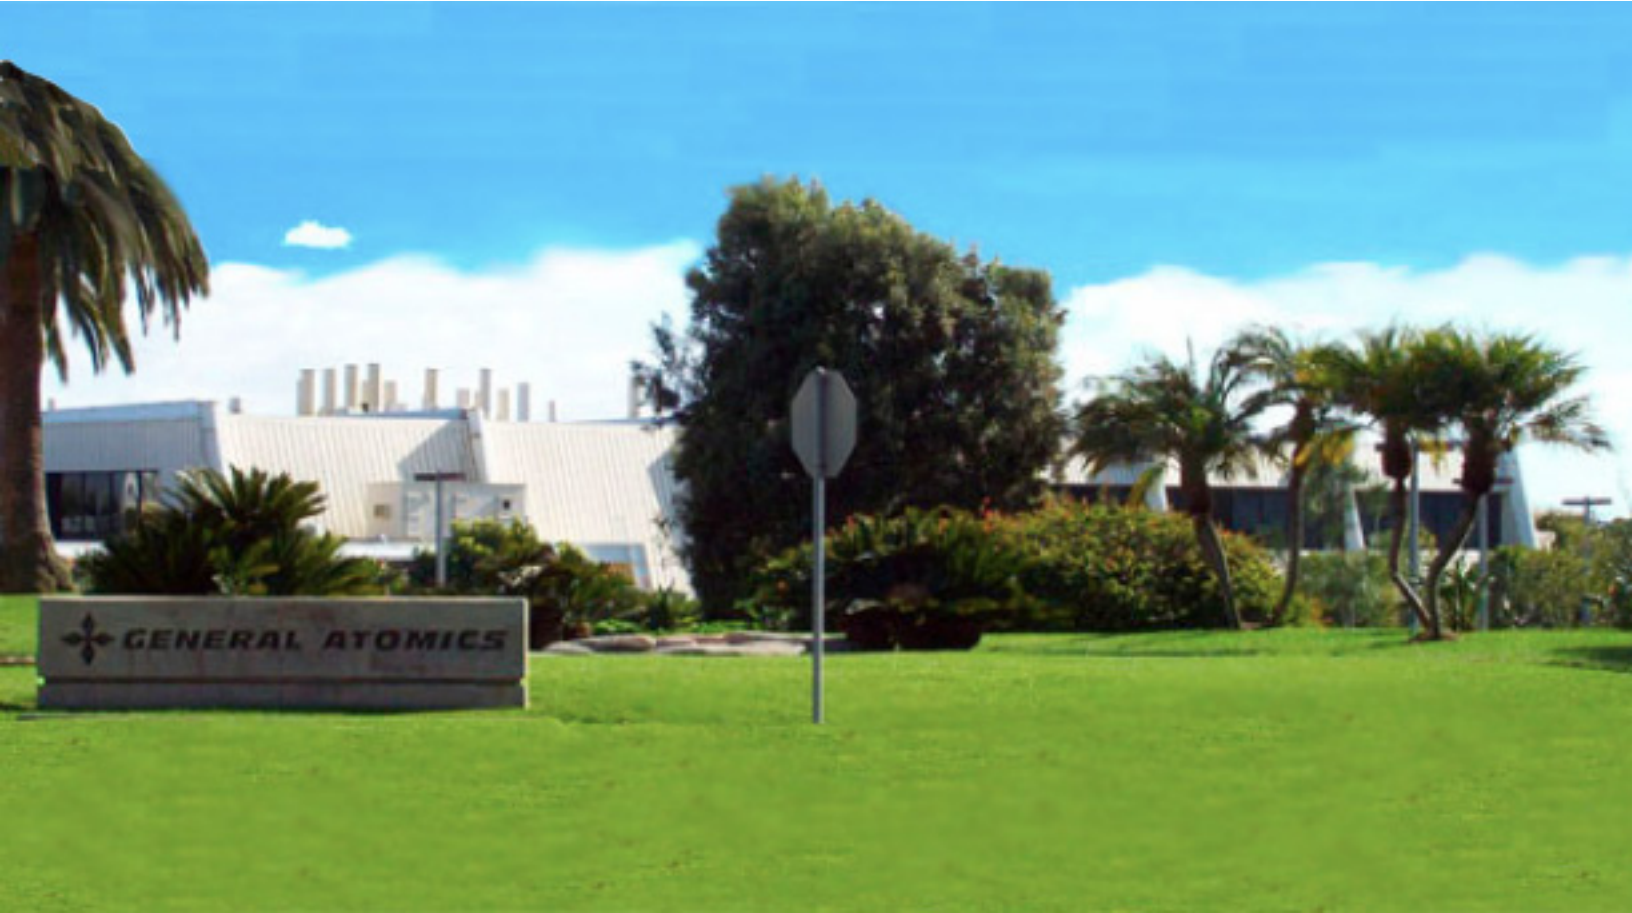
Sanitary drain line had reduced water flow and backups because of cracking, root intrusions and weakened joints. The system consists of 6" clay pipe connected to 4" PVC pipe, beneath a layer asphalt.

The pipe is below an entrance to the building, so Nu Flow's trenchless technology prevented disruption to the office's normal operations. Nu Flow cleaned the pipe system, restoring flow, and then installed our structural drain liner to prevent future problems.
