## Grossmont Shopping Center: Lateral Sewer Line Rehabilitation

Location: La Mesa, California

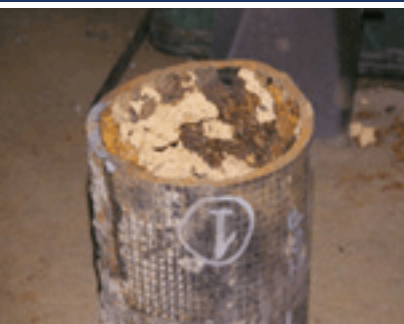
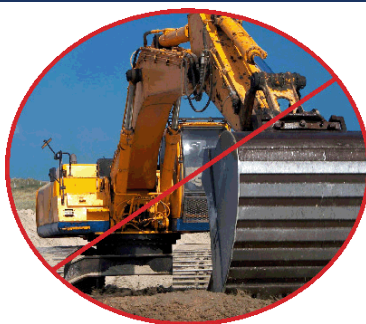
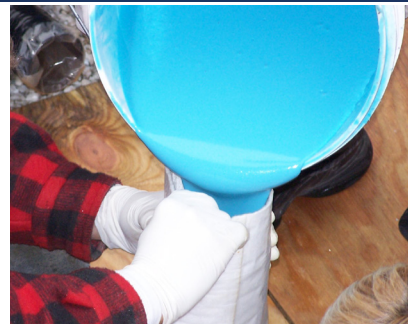
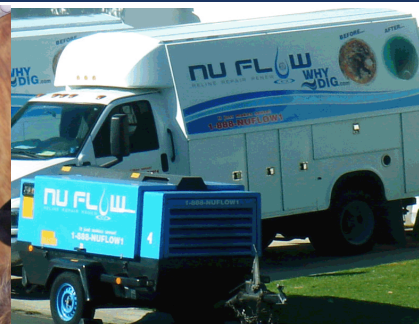
The cast iron sewer line experienced clogging and backups as a result of corrosion. The lateral sewer line includes 4" cast iron pipe installed in 1961 and is located under the Barnes & Noble sales floor and the Starbucks.

Nu Flow was able to clear the corrosion and line the sewer system using our no-dig technology. The aged pipes were returned to their original inside diameter, and the structural liner left inside the host pipes will prevent future problems.
