## Lee County Jail: Sanitary Drain System Rehabilitation

Location: Fort Myers, Florida

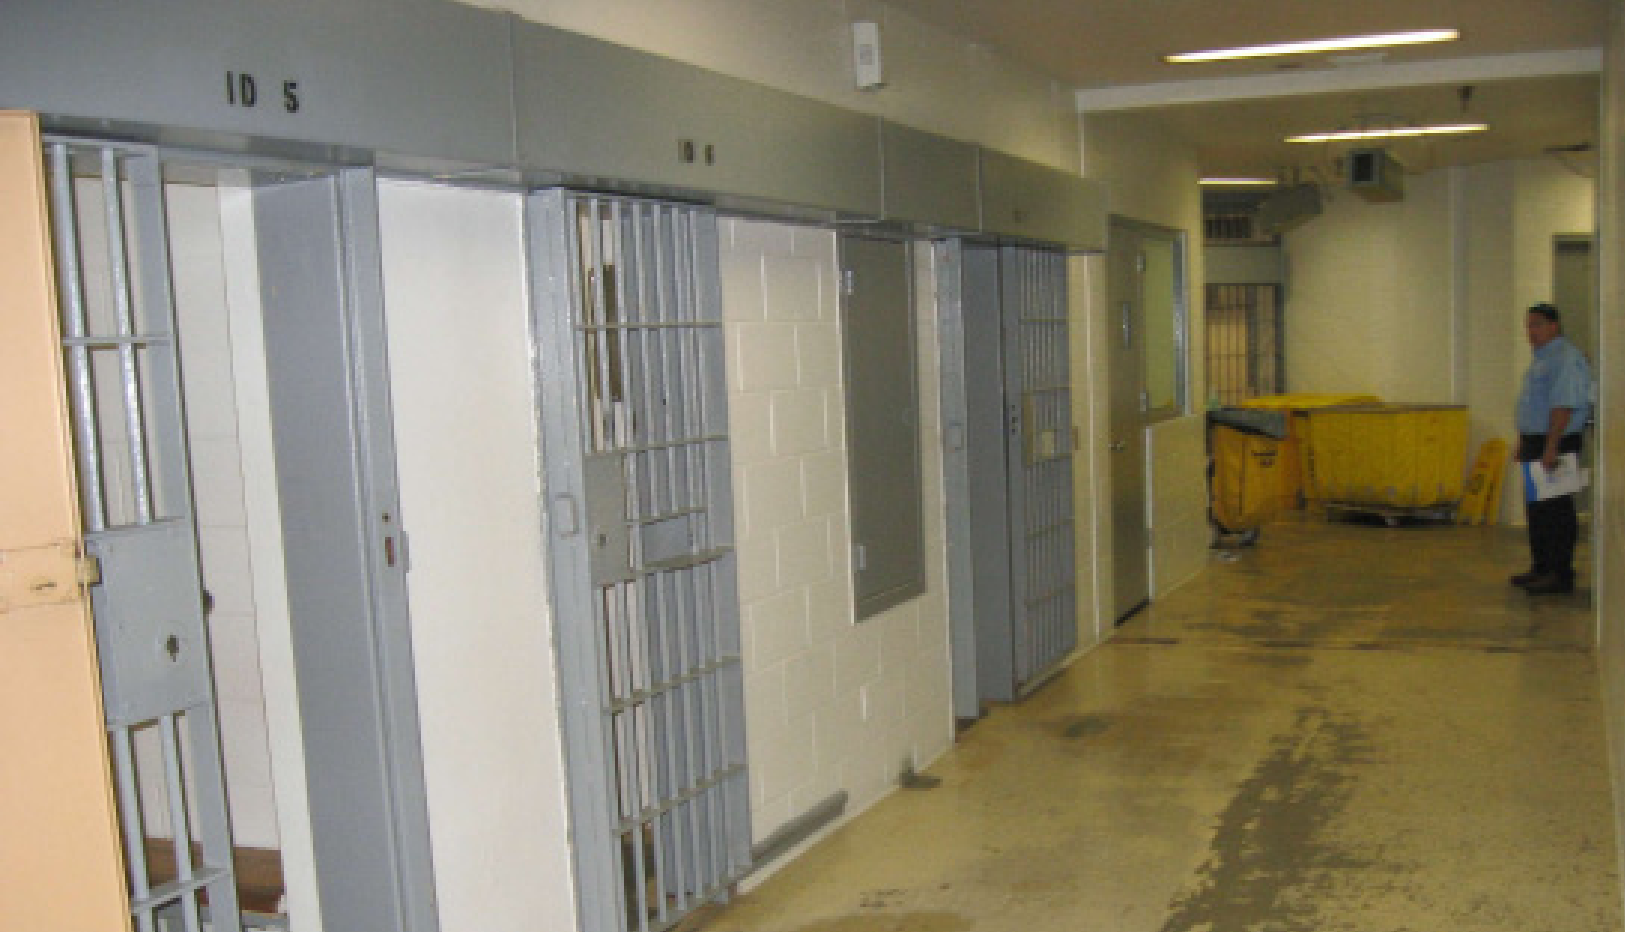
4", 6" and 8" diameter cast iron sewer drain pipes under the slabs in half of the 5-story jail were corroded, causing back-ups and limited water flow.

Digging through the foundation was not an option, because the facility had to have the sanitary system operational and the jail was at 94% capacity with no room to move the inmates. Nu Flow's patented Pull-in-Place structural liner was inserted without destruction or disruption.
