One America Plaza Office Building: Drain and Vent Line Rehabilitation

Location: Downtown San Diego, California

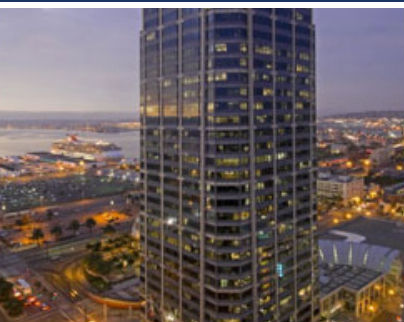
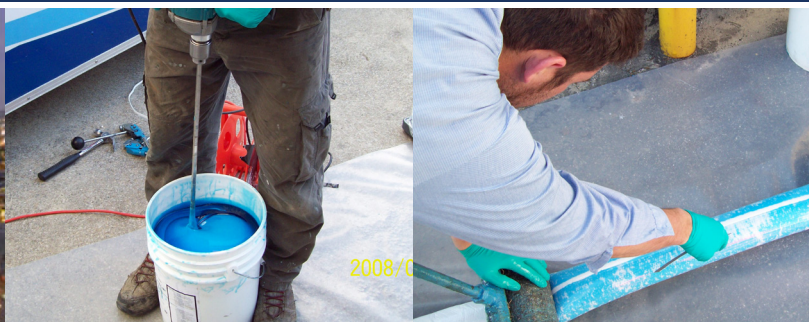
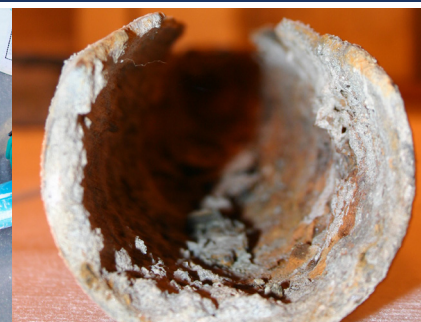
Three separate segments of 19-year-old 6" cast iron vent line were failing due to corrosion and scale flakes in the system. The drain and vent lines are located behind finished tenant spaces and walls.

Nu Flow's patented Pull-in-Place structural liner was installed, saving the customer from costly and disruptive repairs. Nu Flow's work did not interfere with the office building's operations and our structural liner is a long-term solution against future vent system problems.
