Sarasota County: Sanitary Drain Line Rehabilitation

Location: Sarasota County, Florida

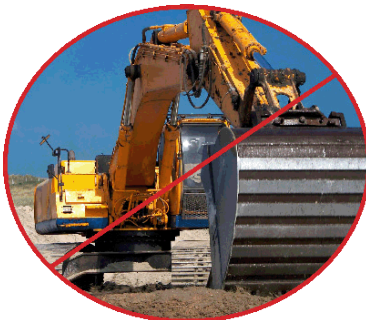
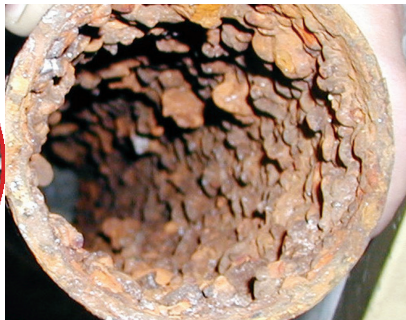
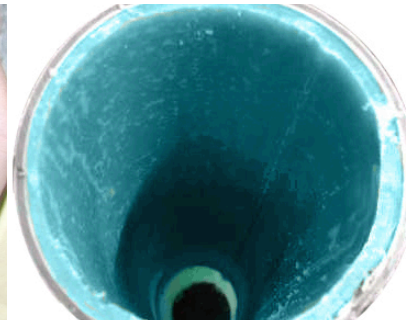
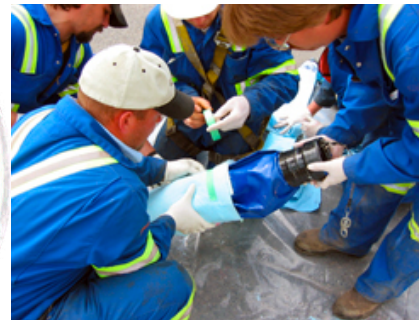
The county's sanitary drain system, primarily 6" diameter clay pipes, experienced rainwater infiltration through broken and cracked pipe joints. The county resorted to hauling the excess wastewater to relieve overloaded pump stations, incurring unnecessary expenses and overtime.

Nu Flow retrofitted the lateral lines connected to the city main with our Pull-in-Place structural drain liner. Our lateral connection liner (LCL) rehabilitated the weakest point in the sewer mains and provided the county with a significant return on investment, preventing further infiltration.
