## ***York University Glendon Campus Cafeteria: Drain System Rehabilitation***

Location: Toronto, Canada

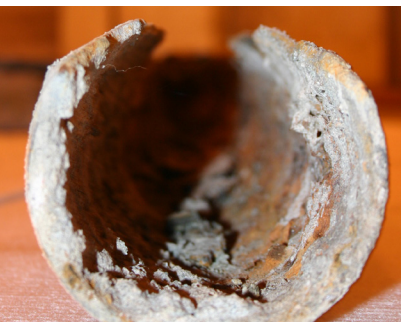
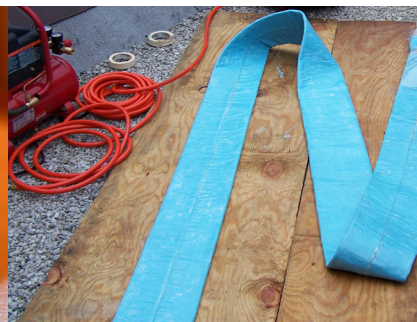
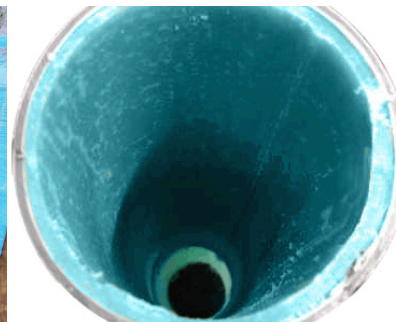
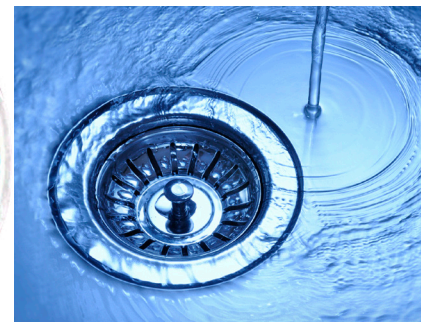
The cafeteria's 24-year-old 4" cast iron dishwasher drain pipe system experienced severe corrosion, leaks and low flow from heavy scale build-up throughout the years. The customer was sick of the pipe system failures but did not want the mess and disruption from a re-pipe.

Nu Flow's "high temperature" epoxy accommodated the 140-degrees dishwasher water. Our patented Pull-in-Place structural liner was installed using existing access points, which prevented the need to dig up the kitchen. This liner protects the drain lines from future failures, including leaks.
