## *Glendale Center Retail Building: Vertical Drain Line Rehabilitation*

Location: Glendale, California

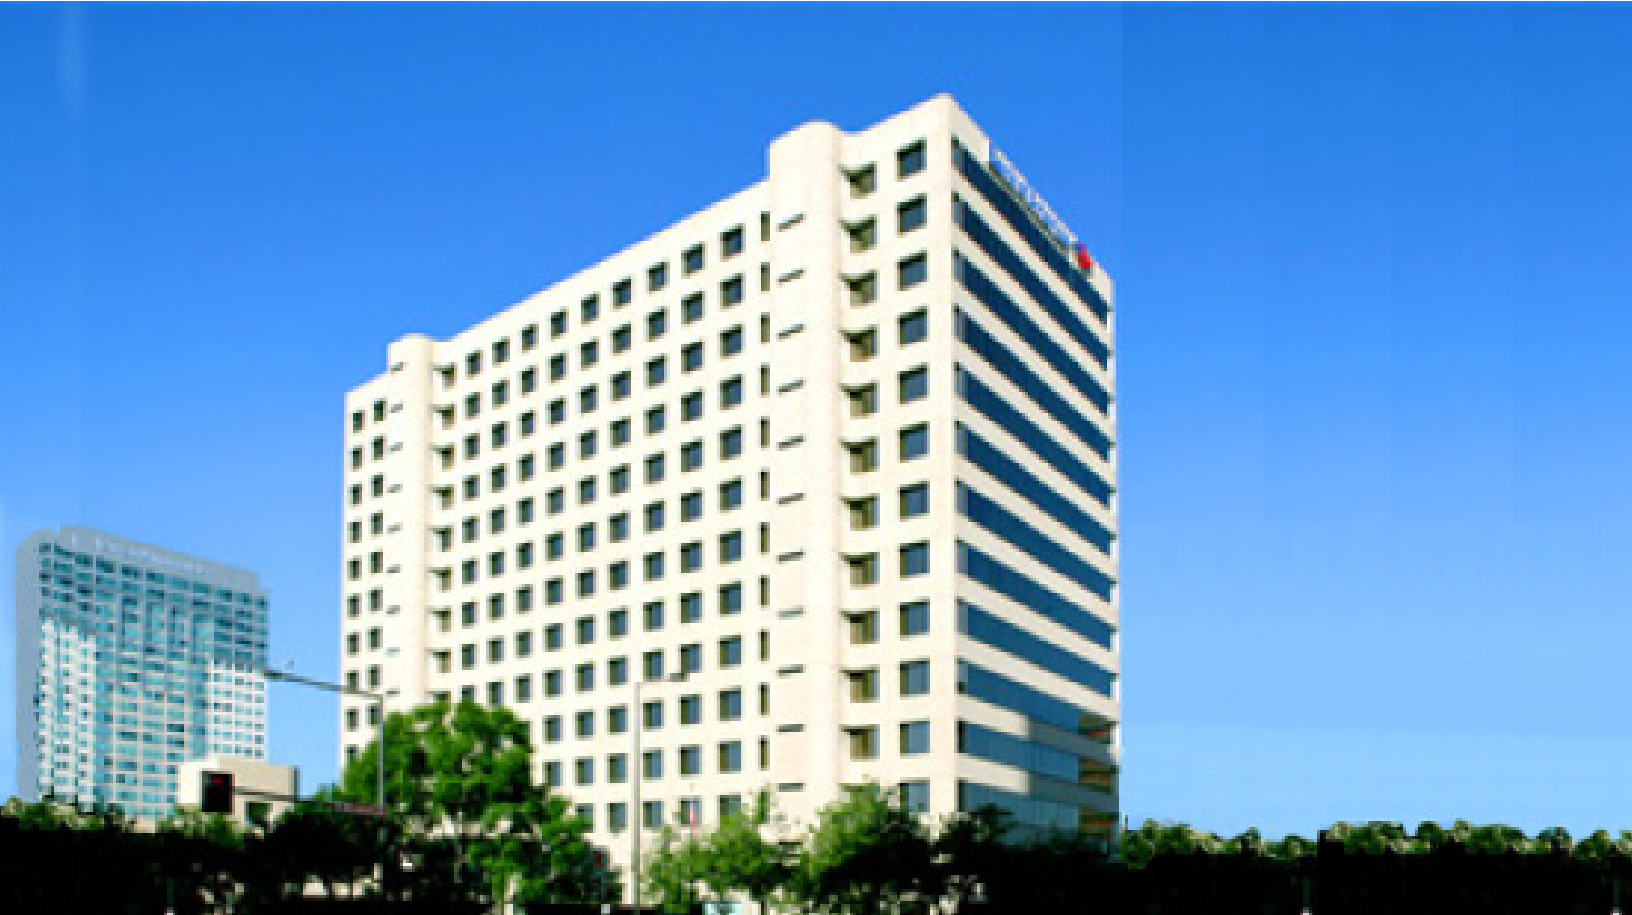
Branch pipe lines from the urinals were experiencing low flow because of buildup and corrosion. The cast iron system consists of 170 feet of pipes with a 4" diameter and 24 feet of 2" branch lines.

Nu Flow cleaned and rehabilitated all 14 floors of the vertical drain line with their structural liner. Thanks to Nu Flow's no-dig technology, work took one week with minimal disruption to tenants, compared to a three week destructive job for traditional repairs and re-piping.
