## *Palm Place Condominium: Sanitary Drain Stack Rehabilitation*

Location: Sarasota, Florida

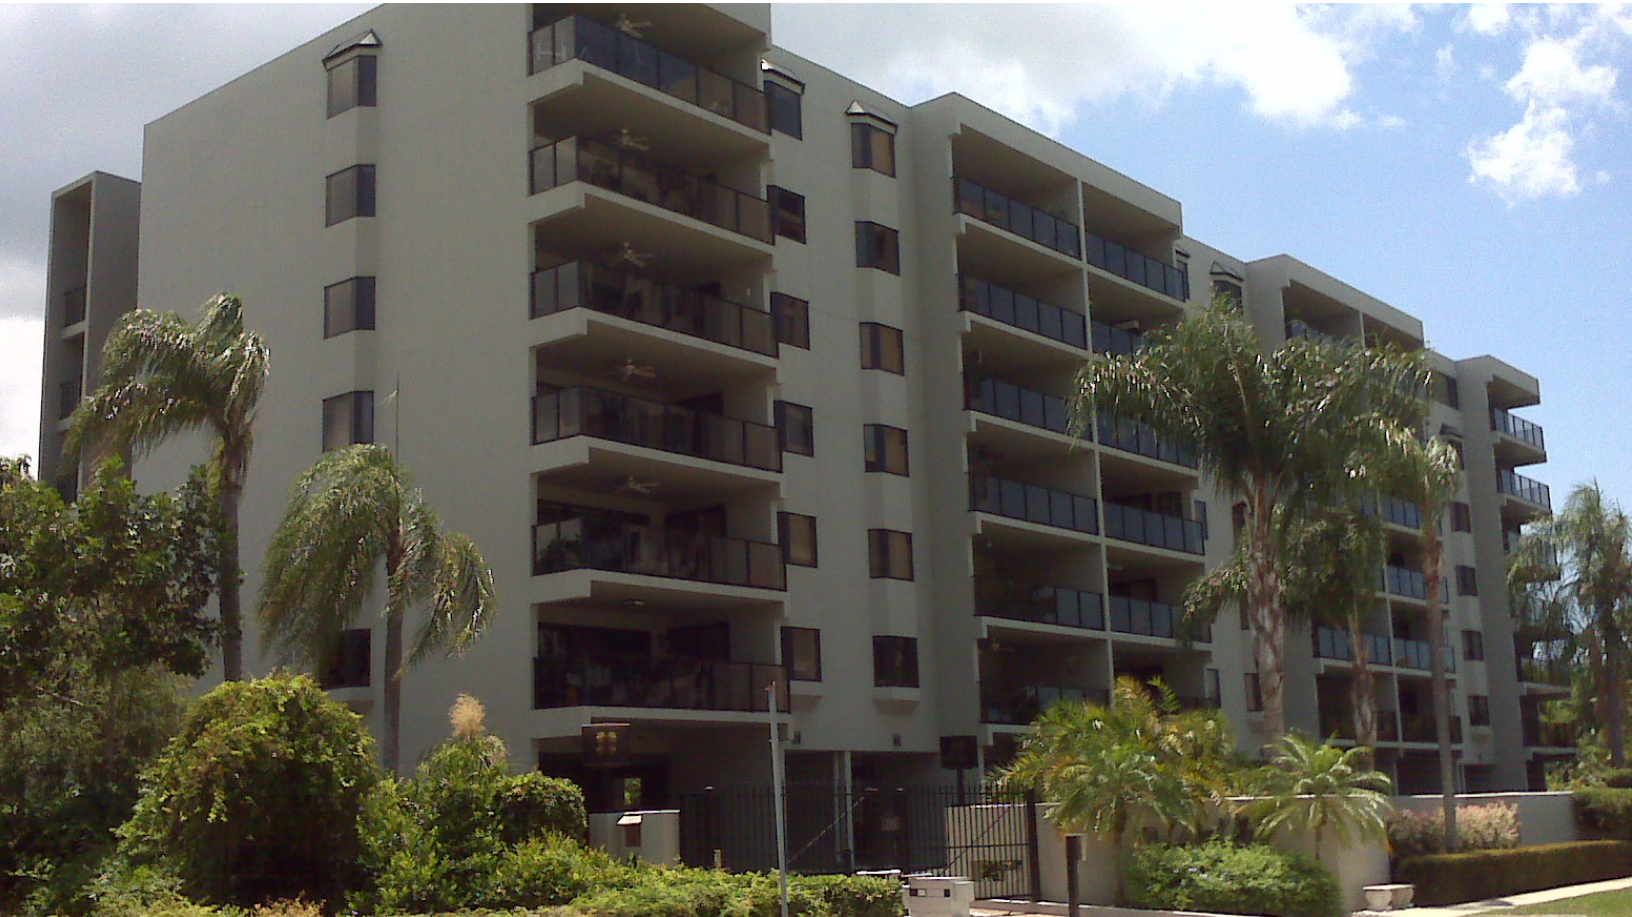
The six-story building has sanitary drain stacks that consist of 360 feet of 3" and 720 feet of 4" cast iron pipe. The 28-year-old stacks were failing due to heavy corrosion and scale buildup.

Nu Flow cleaned and retrofitted the sanitary drain stacks with our seamless, protective liner. A repipe could not be considered as an option because of the destruction it would cause. Nu Flow's solution did not cause destruction of the building or disruption to residents.
